Section 19 Flood and Water Management Act 2010

Framlingham Flood Investigation – Storm Babet 2023

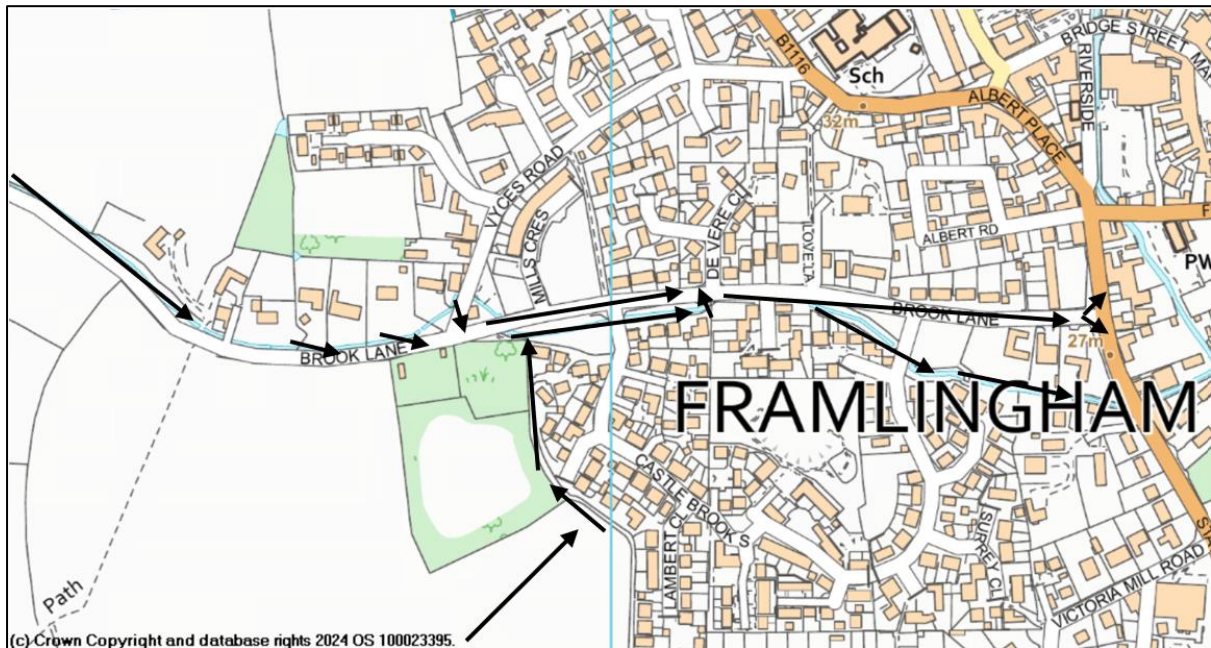
Figure 10 - Approximate flood water flow routes in West Framlingham

The primary source of flooding in the west of Framlingham was fluvial, with flood water overtopping the banks of the Cherry Brook watercourse. This was contributed to by surface water run-off from higher ground and the additional backing up of flood water from the culvert under The Mills. Brook Lane is aligned along the major flow path from the west coming into central Framlingham (Figure 5).

The Cherry Brook watercourse breached its banks early on 20th October and caused flooding of the adjacent Brook Lane (Image 3). The overtopping of the watercourse effectively creating a second flow path along the road, following the natural gradient towards Station Road (Image 9). This substantial amount of flood water is likely to have been greater than the design capacity of the highway gullies. This correlates closely with the predicted flood risk maps, with fluvial risk being categorised as Medium to High and the pluvial flood risk categorised as high along the length of Brook Lane.

- Investigate potential NFM projects and funding opportunities which aim to attenuate water and 'slow the flow' in the catchments West of Framlingham.
- Remove any observed blockages within main river and ordinary watercourses where flood risk is increased.
- Ensure the completion of highway drainage asset maintenance and investigate if capacity and condition are sufficient.
- Investigate options to connect surface water flowing on Brook Lane back into the river.
- Investigate options to improve the capacity of the culvert below The Mills on Brook Lane.

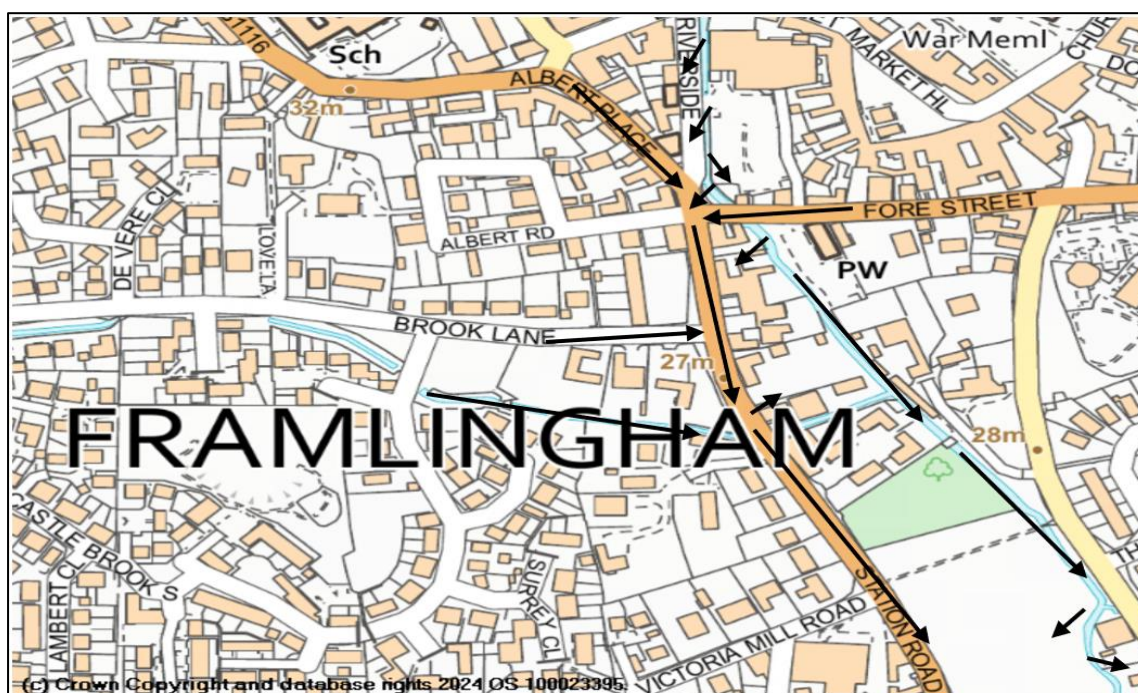
Figure 11 - Approximate flood water flow routes in Central Framlingham

The primary source of flooding in central Framlingham was a combination of fluvial and pluvial flooding, with flood water from the river and roads merging. The banks of the River Ore overtopped and combined with surface water flows from the north (Bridge Street, Well Close Square), the east (Fore Street) and west (Brook Lane).

The River Ore burst its western bank initially at the junction of Albert Place and Fore Street and then south of the Bridge Street and Riverside junction (Image 4). This flood water flowed along Riverside, with the road acting as a secondary river channel, carrying floodwater downstream, inundating Albert place (Image 5). Residential and commercial properties on Riverside were flooded internally to approximately 33cm. The flood waters were added to by surface water from Bridge Street and New Road, flowing into Well Close Square and toward Albert Place. Central Framlingham and Albert Place in particular, being amongst the lowest points in Framlingham, acted as the central basin into which a combination of pluvial and fluvial floodwater accumulated. The roadside drainage assets were completely overwhelmed. Outfalls for highway drainage were quickly submerged as they fell below the peak river level, were unable to discharge fully into the river and caused water to back up.

The flood water continued to flow south from Albert Place where the road and river diverge. At this point, the road became the primary channel for flood water flows, further building up through lateral pluvial inflows from Fore Street (coming downhill), Albert Road and multiple gardens. This merged with flood water flowing from the west along Brook Lane, flooding properties adjacent to Station Road between Albert Place and the junction with Brook Lane. Evidence suggests that the primary direction of flooding was from the front, i.e., from the road.

- Investigate potential NFM projects and funding opportunities which aim to attenuate water and 'slow the flow' in the catchments surrounding Framlingham.
- Remove any observed blockages within main river and ordinary watercourses where flood risk is increased.

- Ensure the completion of highway drainage asset maintenance and investigate if capacity and condition are sufficient.
- Investigate any capital interventions that can improve the flood resilience of the town.

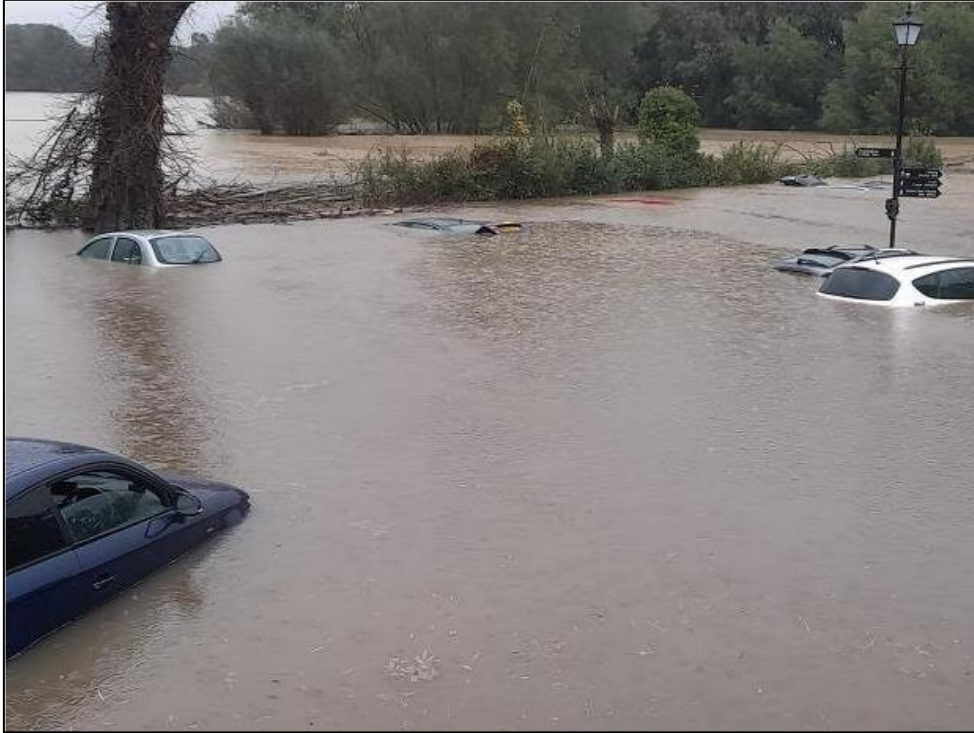
The primary source of flooding in the north of Framlingham was fluvial flooding, from the overtopping of the River Ore and the Mere through which the Ore flows. There are five overland flow paths that feed into the Mere from the Upper Catchment above Framlingham. Residents reported that the water flows in both the River Ore and Mere rapidly expanded on the morning of Friday 20th. After overtopping the banks, overland fluvial flows quickly moved towards The Elms car park where depths reached approximately 150cm (Image 1). The depths in the car park increased and the area of flooding was enhanced by pluvial flows coming from New Road.

Image 1 - Flooding of The Elms car park and The Mere

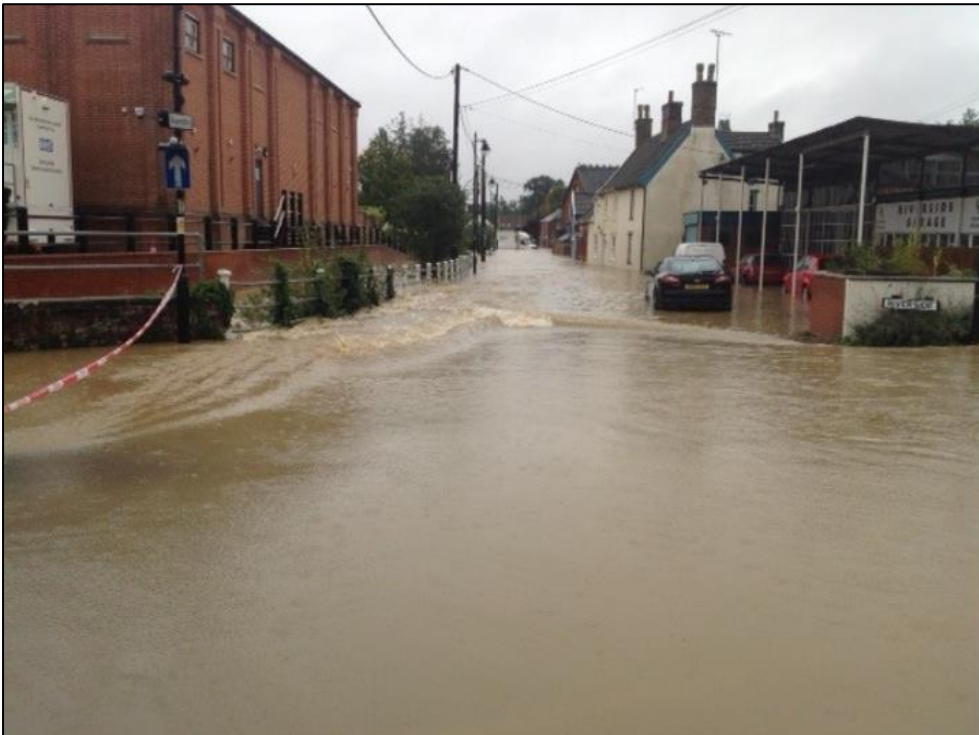
Flood water continued through the car park to flood the Elms residential area from the rear, inundating the entire area. This was increased by the surface water run-off flowing eastwards off New Road towards the residential area and the car park from the west and northwards from Bridge Street. Residential housing was flooded internally to a depth of approximately 80cm. All ground floor premises are thought to have been flooded (approx. 10). Residential, commercial properties and the road on Bridge Street were also flooded as the river overtopped between the road bridge and the Mere. Reports from residents suggest that there were blockages, most likely woody debris from the Mere, under the bridges over the Ore in this area which may have contributed to overtopping of the river channel. The combined fluvial and pluvial flood water flowed South and West towards Riverside and Well Close Square respectively but was limited in the direction of Market Hill by the natural raising incline to the East (Image 2).

Image 2 - Flooding on Bridge Street looking towards Riverside

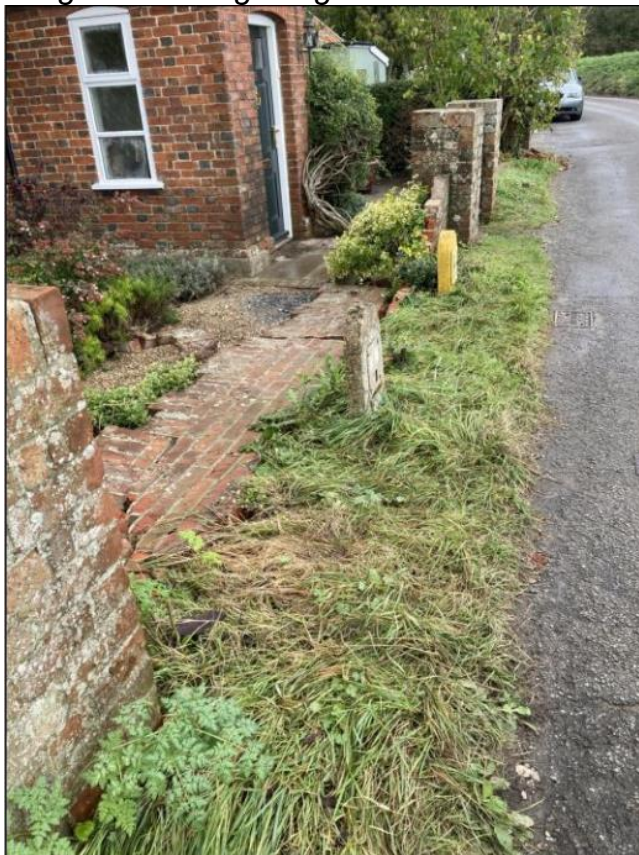
A cluster of residential properties on Fairfield Road near to the junction with Woodbridge Road, experienced flooding from three directions: flood water from the north along Fairfield Road, flood water run-off from the east over the opposite field, and flood water flows to the rear from the river. The initial source of flooding for properties was water flowing off the fields to the east which was described as 'like a tidal wave'. There is no ditch at the bottom of this field where it merges to the footpath. The force of the water knocked over the brick wall in front of one property (Image 7).

Image 7 - Damage to garden wall on Fairfield Road

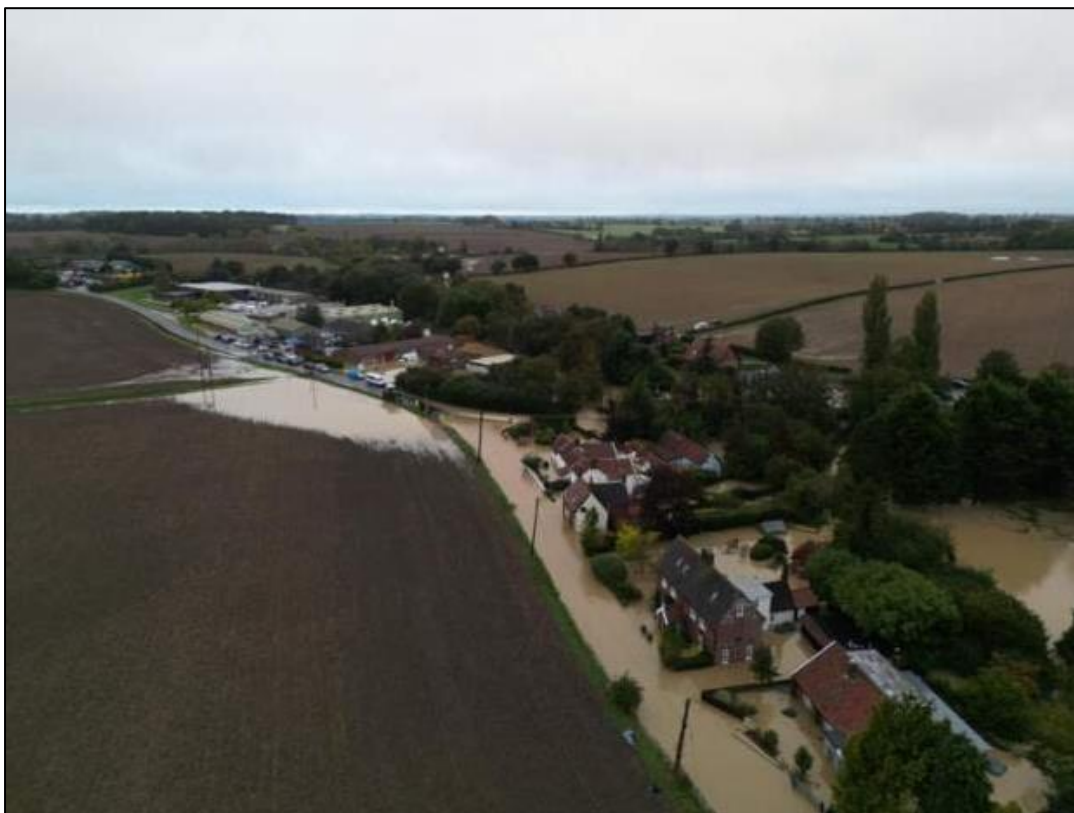
Image 8 - Flooding on Fairfield Road looking towards Woodbridge Road

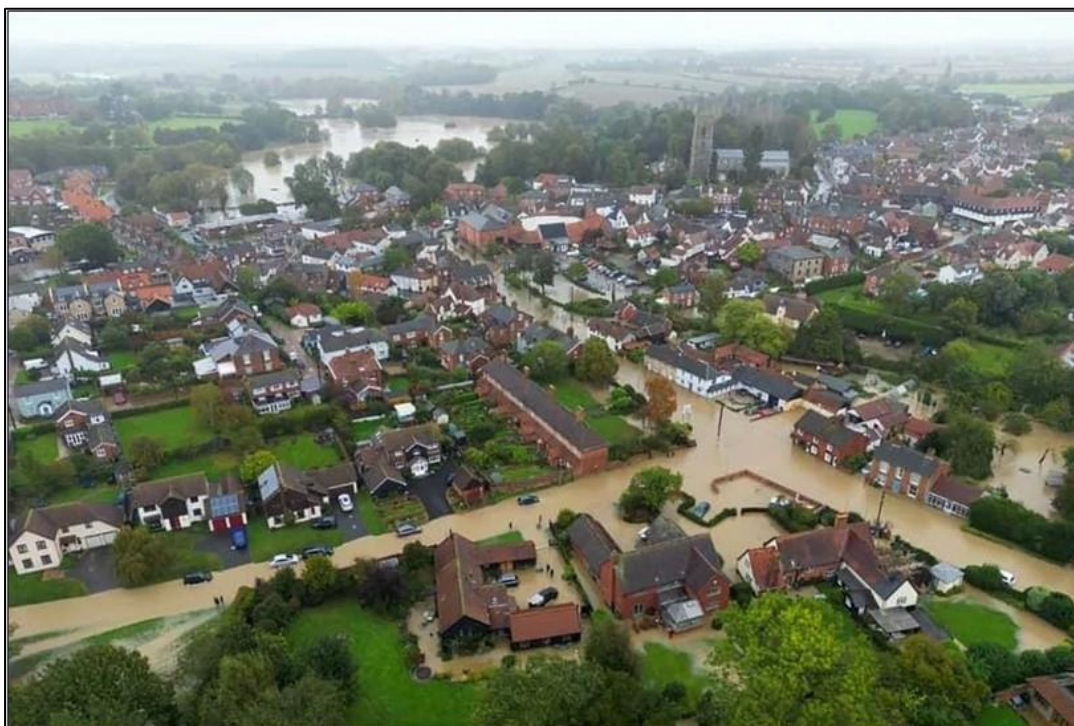
Image 9 - Flooding on Brook Lane and Station Road
