Section 19 Flood and Water Management Act 2010

Framlingham Flood Investigation – Storm Babet 2023

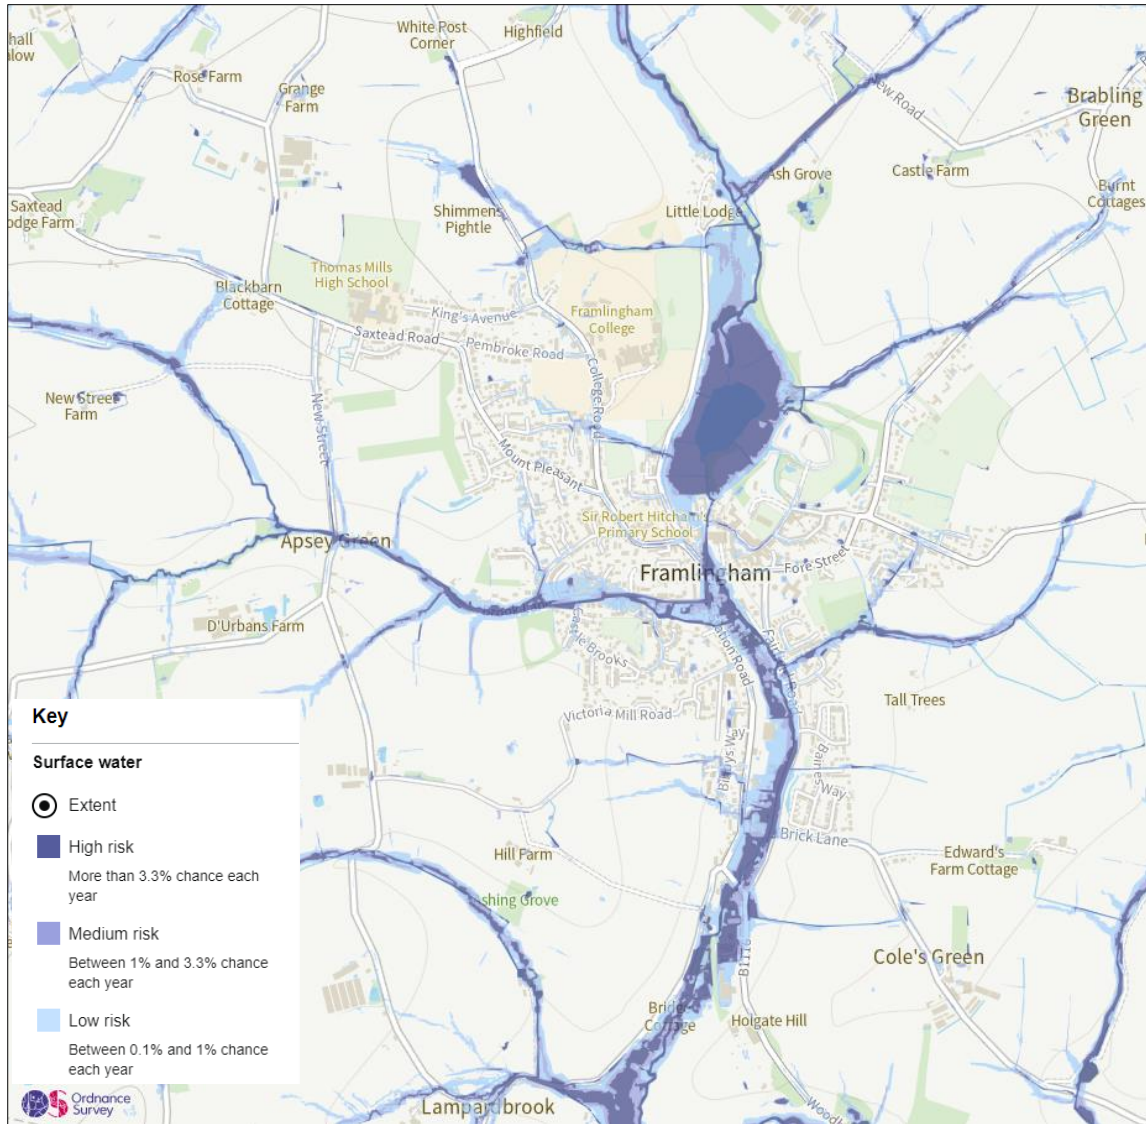
Figure 4 - Predicted Pluvial Flood Risk

Figure 4 highlights the predicted Pluvial (surface water run-off from surrounding land and ditches) flood risk within Framlingham, with six main tributaries flowing into the town. There is significant risk of surface water flooding in Framlingham. Riverside, Albert Place, Brook Lane, Fairfield Road and Kettleburgh Road are all shown as at risk of flooding.

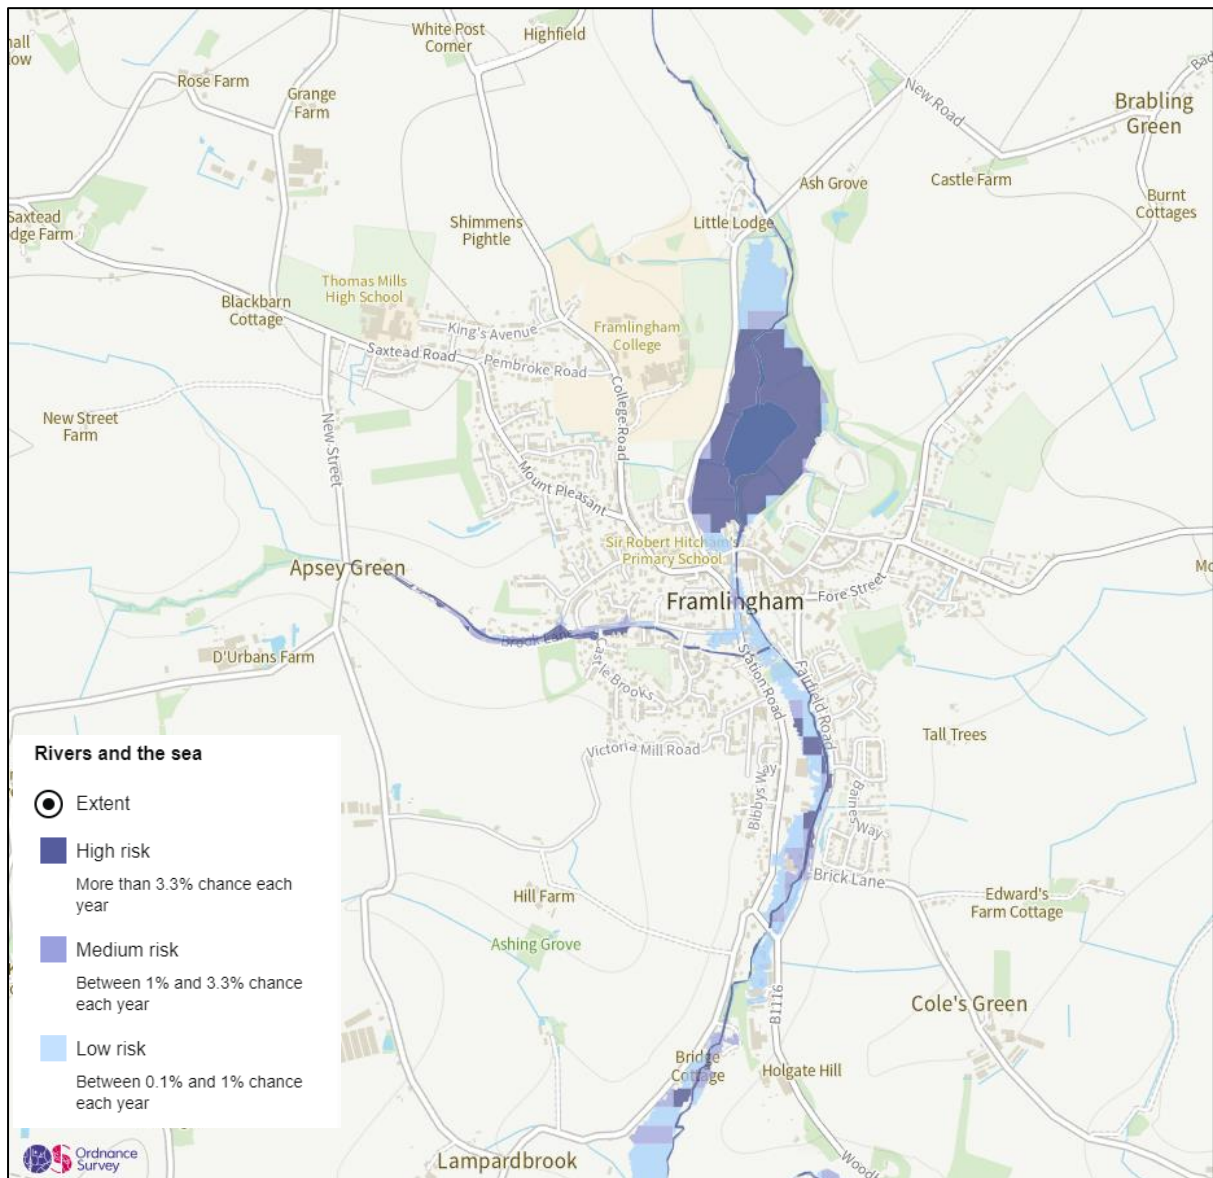
Figure 5 - Predicted Fluvial Flood Risk

Figure 5 highlights the predicted Fluvial (from designated main river) flood risk within Framlingham. The main fluvial influences consist of two designated main rivers, the Cherry Brook watercourse, and the River Ore. The West end of Brook Lane and some areas of central Framlingham are shown as at risk for fluvial flooding.

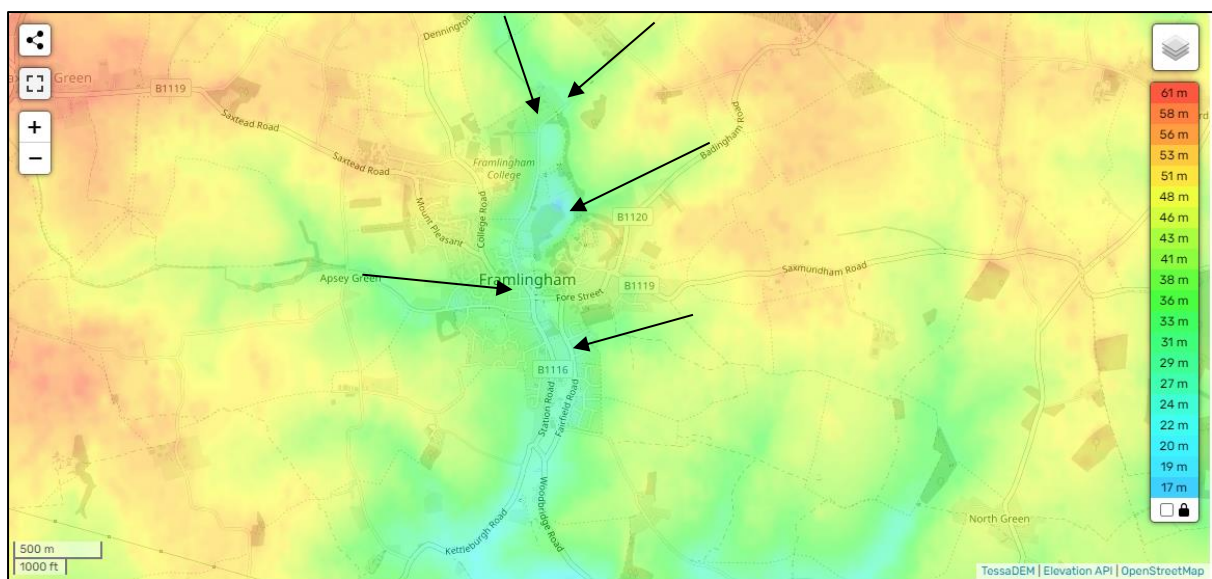
Figure 6 - Framlingham and surrounding topography with approx. directions of the overland pluvial flow paths into Framlingham

Figure 6 shows the topography surrounding Framlingham and the gradient changes across the town. Brook Lane, Albert Place, Station Road & Fairfield Road are among the lowest lying locations in Framlingham. These were identified as being some of the worst affected areas following Storm Babet.

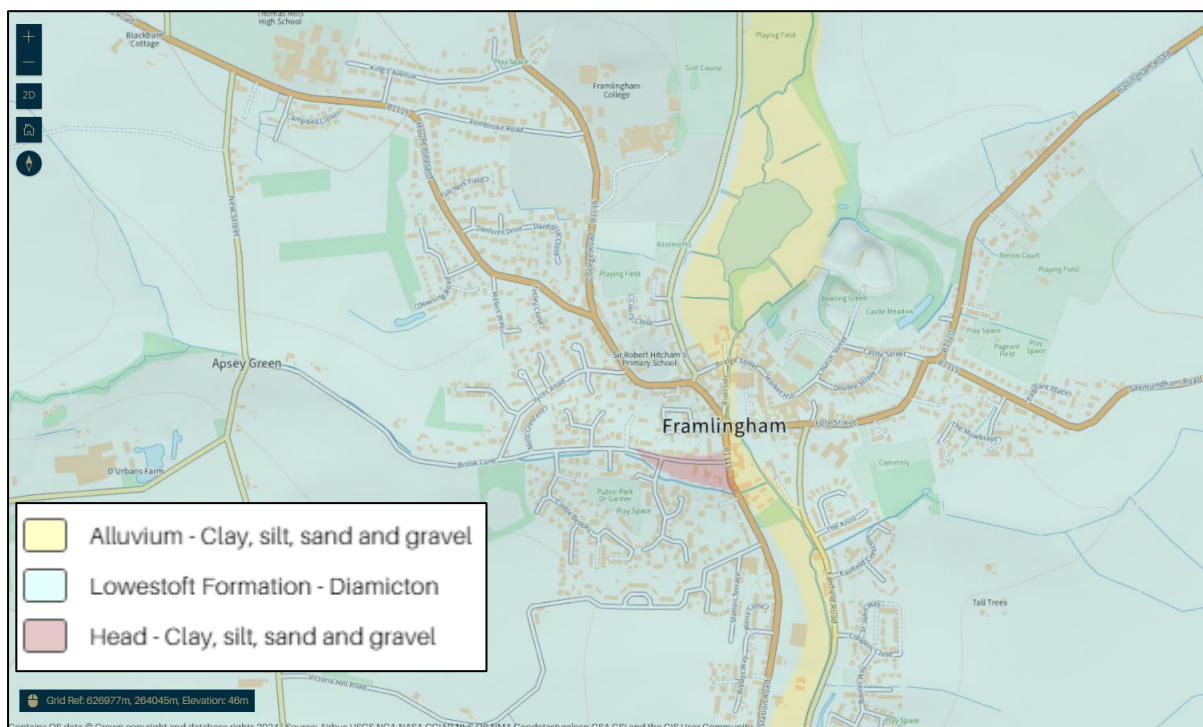
Figure 7 - Framlingham town centre and underlying geology

Framlingham itself sits mostly on Lowestoft Formation ‘Diamicton’ which is described by the British Geological Survey as a diverse mixture of clay, sand, gravel, and boulders varying widely in size and shape. This is sometimes known as boulder clay. This generally has a low permeability meaning water will tend to flow off it before it can be infiltrated, which reflects reports from the event.

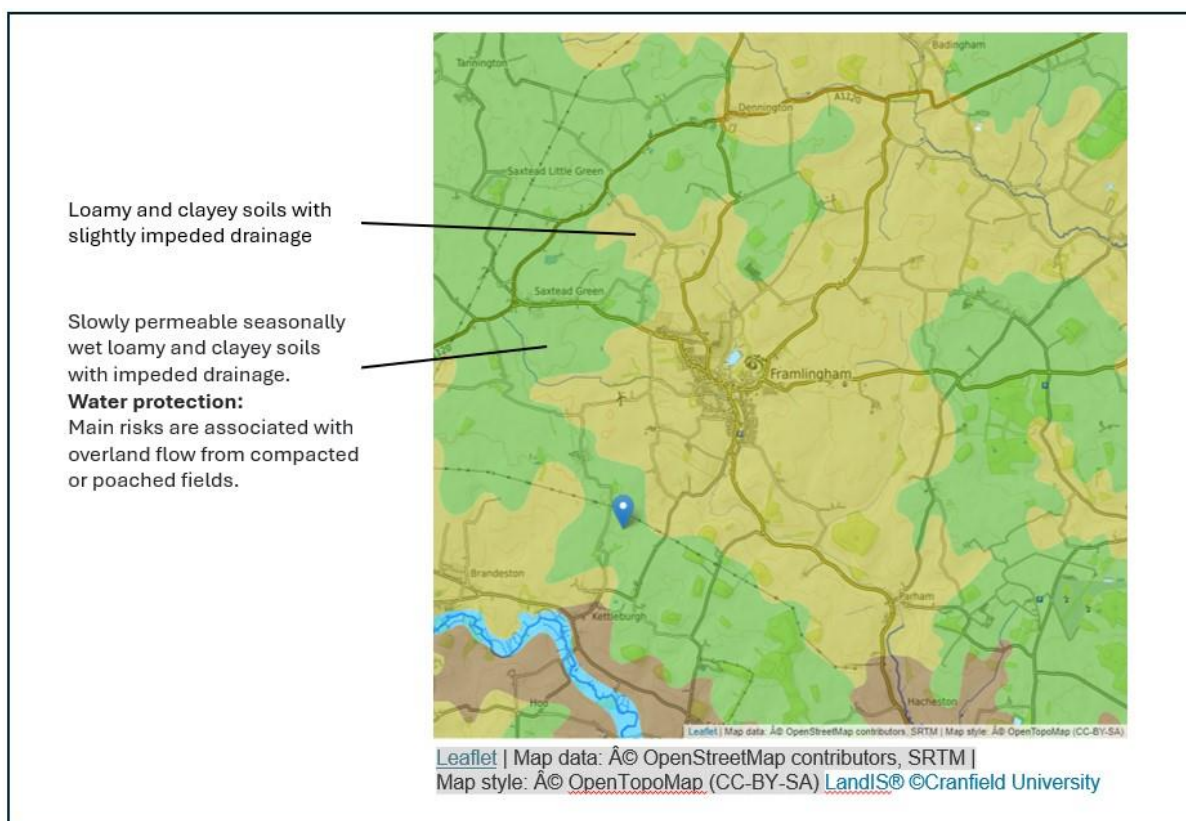
Figure 8 - Framlingham and surrounding soils

With reference to soils in the wider catchment, immediately around Framlingham, they are described as loamy and clayey soils with slightly reduced infiltration (see Figure 8). At the higher levels surrounding the town, the soil is described as slowly permeable, seasonally wet, loamy and clayey soils with reduced infiltration (LandIS, Cranfield University, 2024). Lower rates of infiltration to ground means that more surface water will stay on the surface and not be absorbed, potentially contributing to flood water.
